Report on the 13th Meeting of the Joint Working Group of the U.S-Japan Coordinating Committee of Fusion Energy on Safety in Inter-Institutional Collaborations (U.S.-Japan Safety Monitoring Program) February 22-25, 2010

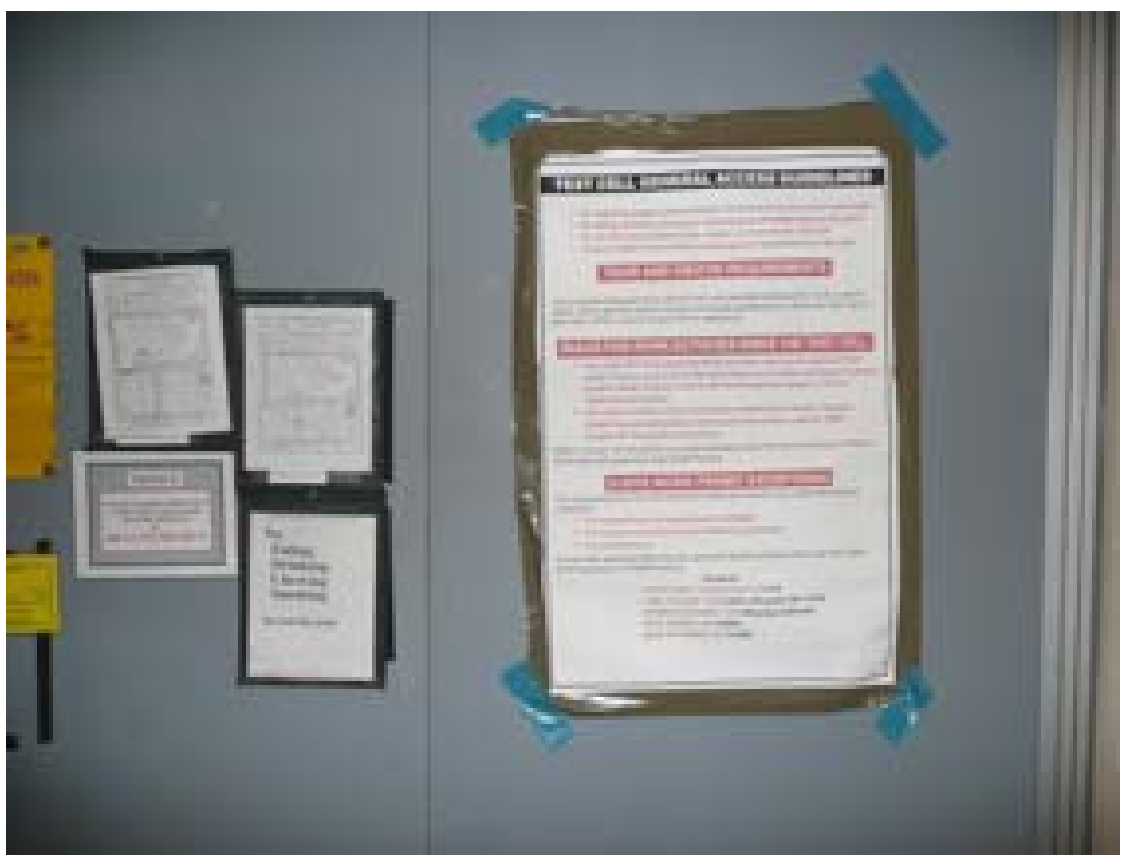
The experimental hall of TFTR is still keeping as a restricted area. Indication of “Restricted Area” is put up on the entrance door. The entrance in the hall is controlled by keys (Fig. 17).

Fig. 17. Entrance of the TFTR Hall (door keys and a notice.

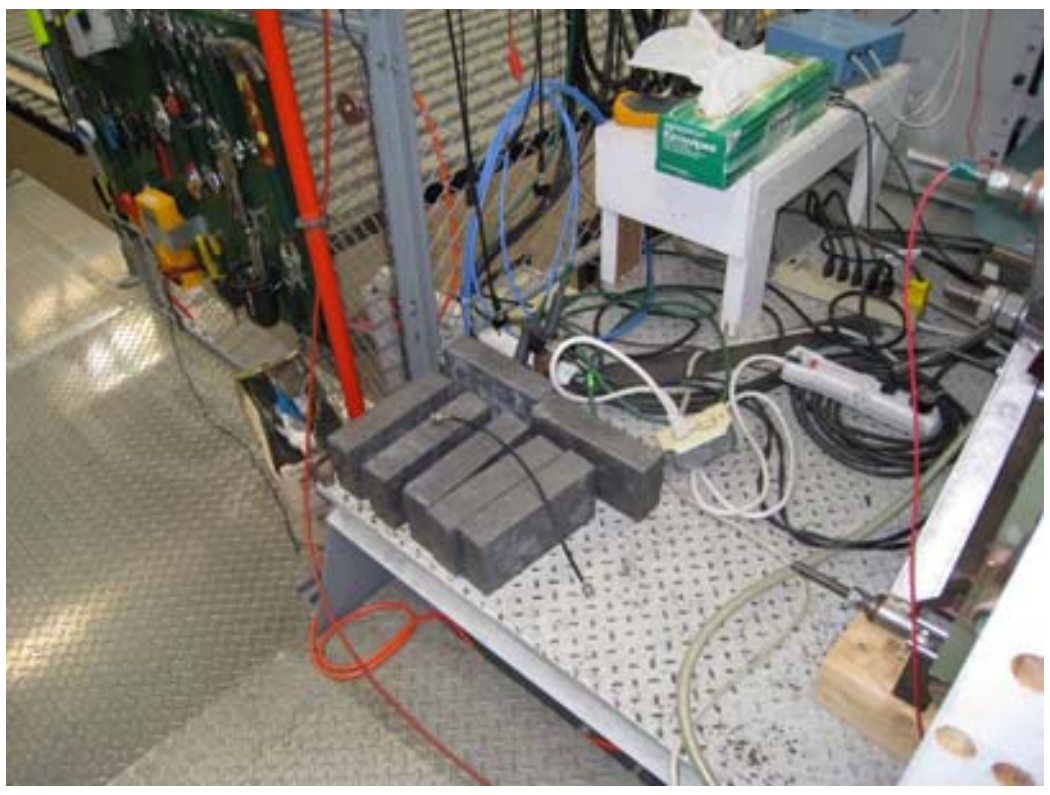
Blocks of lead were put on the stage without any coatings. Powder of lead and lead oxide may give damage to the health. To keep lead without coating is forbid in Japan (Fig. 27). (K.N.)

Fig. 27. blocks of lead on stage without coating.

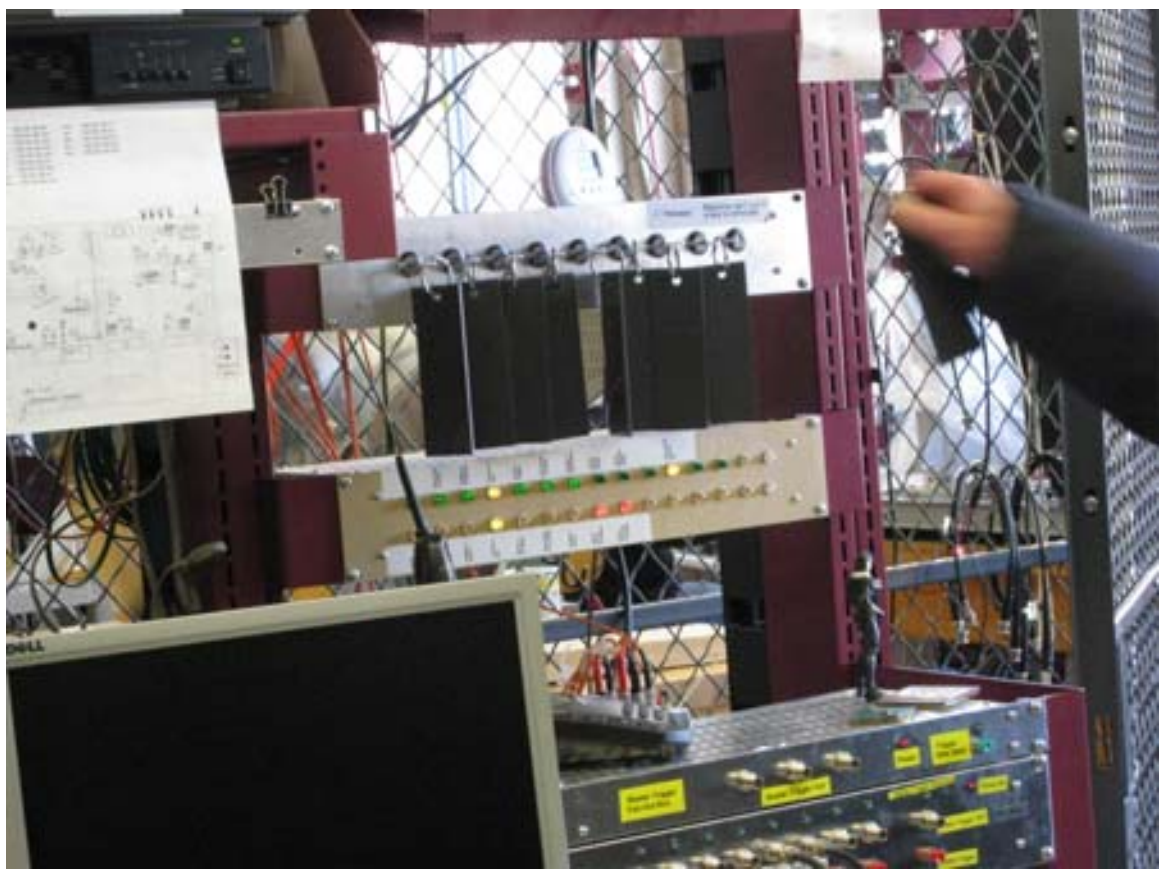
Door access is controlled by using the keys and it is linked to the interlock system (Fig. 28). It is simple and effective. (K.N.)

Fig. 28. Keys for door interlock.

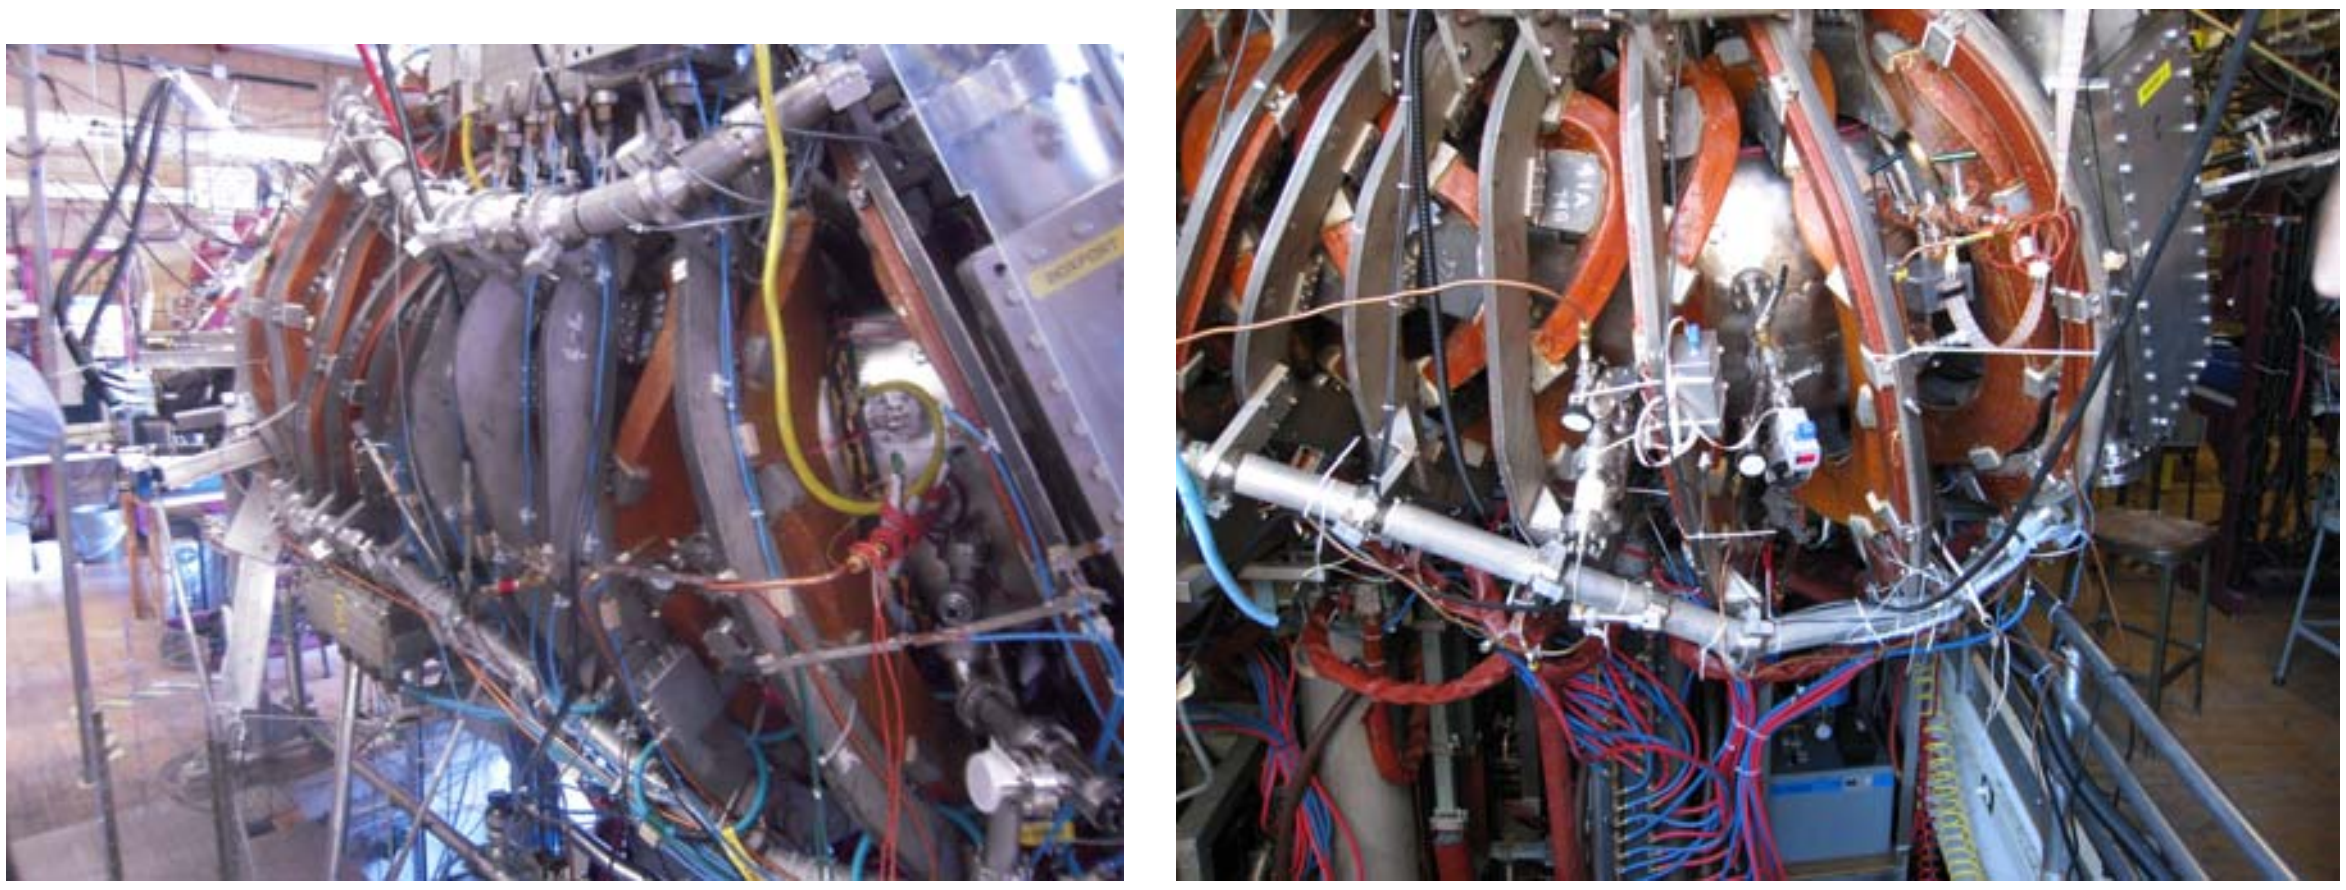
Please take care of the injury of researcher by projecting things around the machine, and projecting things itself may suffer serious damage by accidental hit (Fig.30). (A.S. & K.N.) Especially the damage to eye by the rest part of the bundling wire is serious. (K.N.)

Fig. 30. Projecting things around the machine.

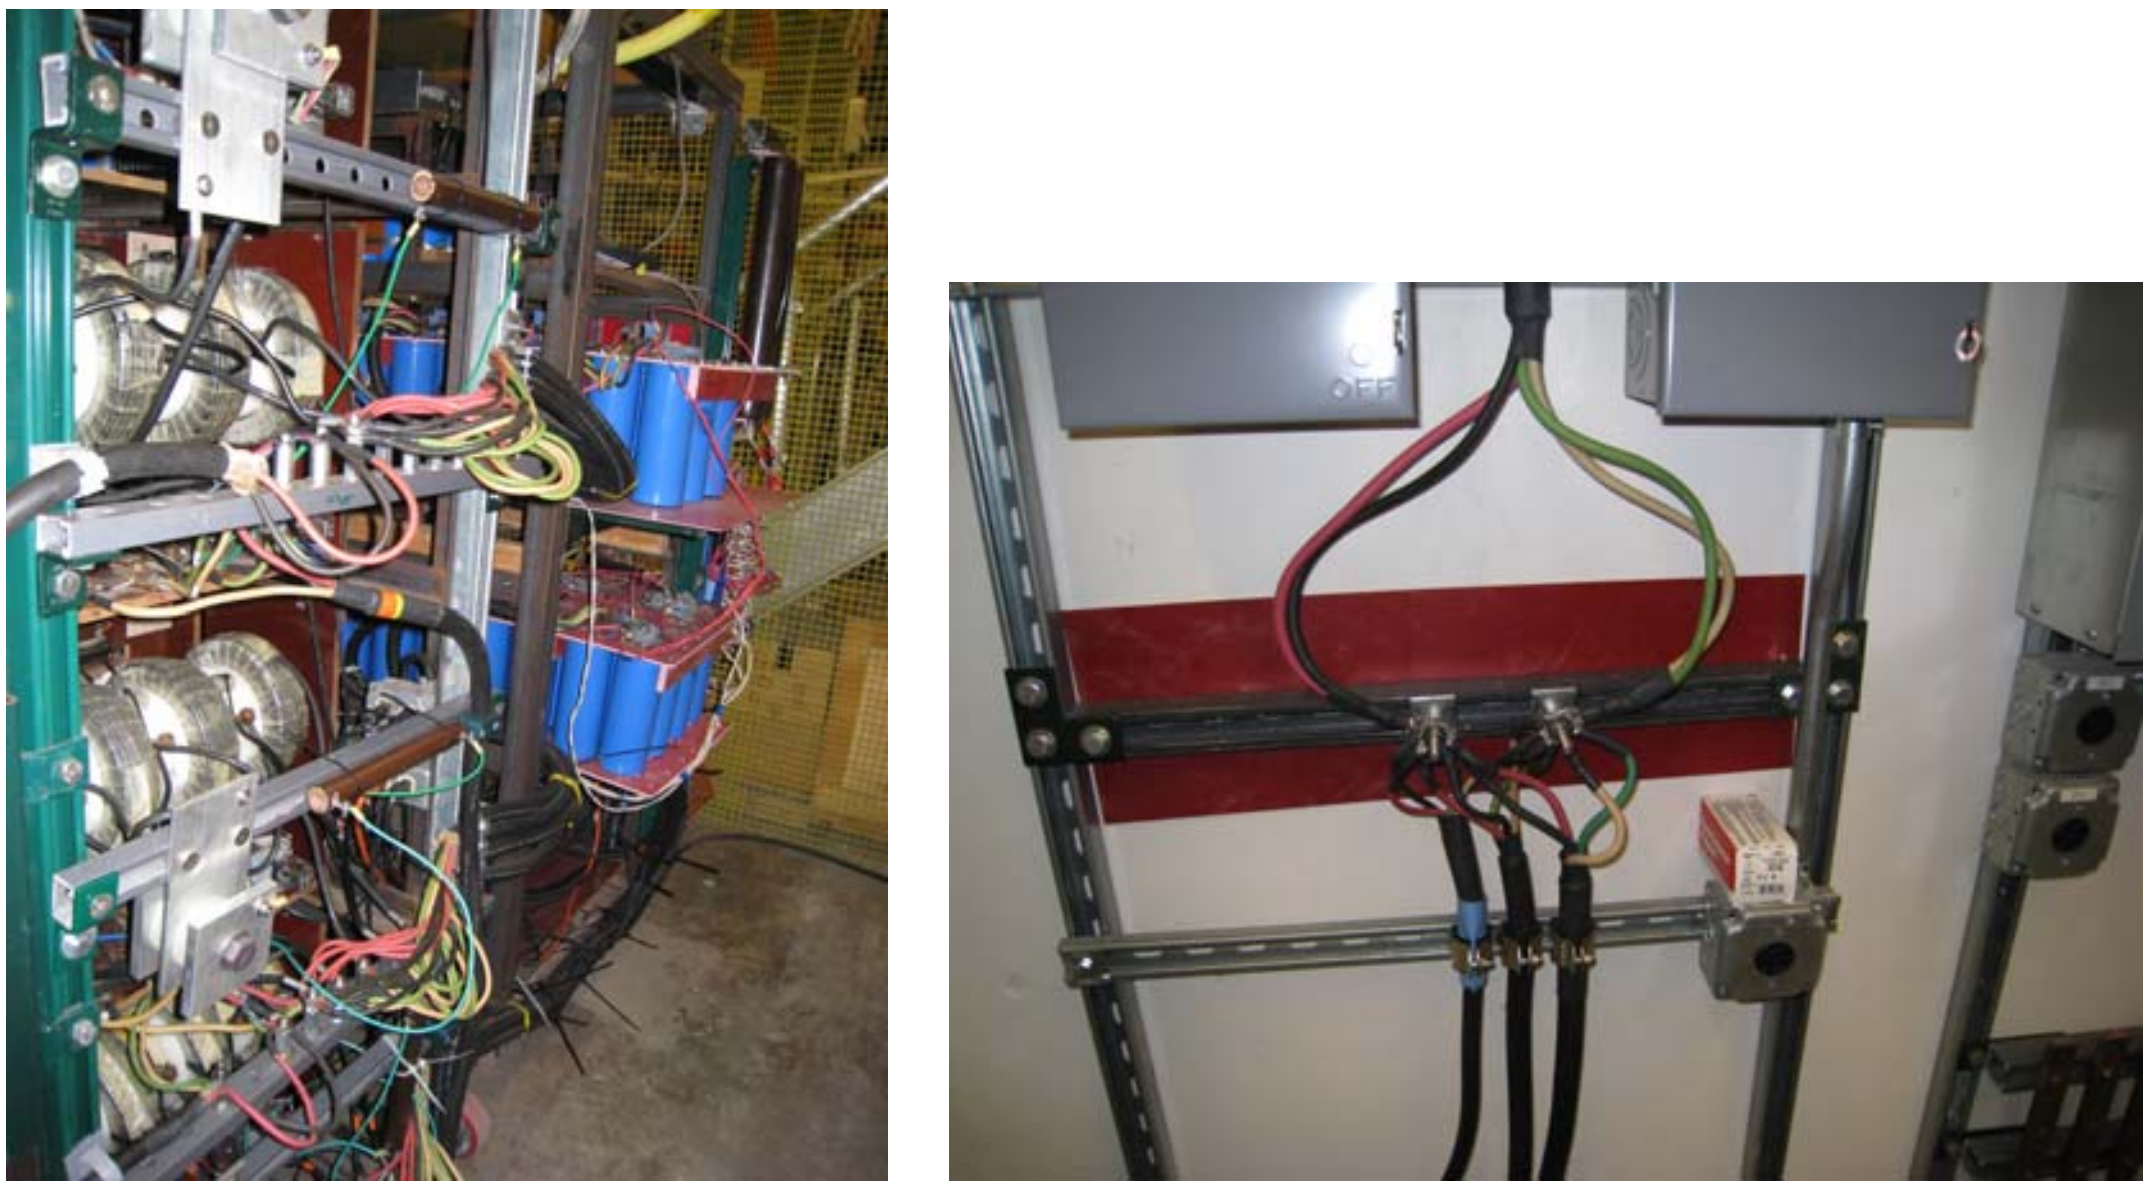
The current terminals of power line should be coved with protecting cover to prevent an accident of electric shock (Fig. 39). (K.N.)

Fig. 39. Power line terminals without protecting cover.
